Restoration of Luggage Truck commencing February 2025

The luggage truck employed on the Hythe Pier Railway is owned (as is the rest of the locomotives and rolling stock) by the Hythe Pier Heritage Association (HPHA), having been gifted in 2023 by previous owner Blue Funnel Ferries, and is leased for operation on the world's oldest continuously electric train operating on a pier, to the Hythe and Southampton Ferry Company.

It was withdrawn from service during early February for restoration, a part of HPHA's continuing programme of restoration projects for the Hythe Pier Railway.

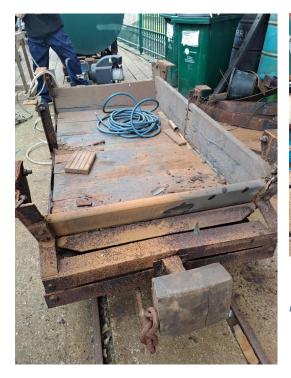
Photos: Alan Titheridge (February 19, 2025)

Disassembly commenced duruing mid February, with the luggage truck having been shunted and parked on the siding outside of the workshop.

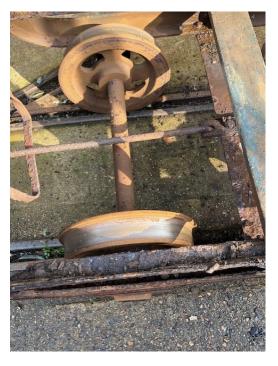
Photo J Drodge

Wheels and Axels checked and appear in good condition.

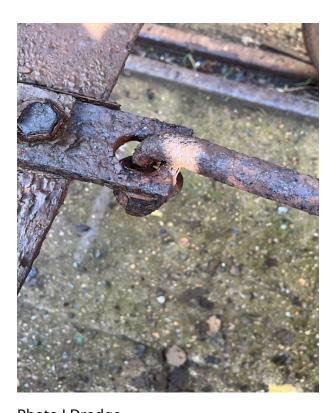
Photo J Drodge

Coupling bars showing signs of excessive wear and will require replacement.

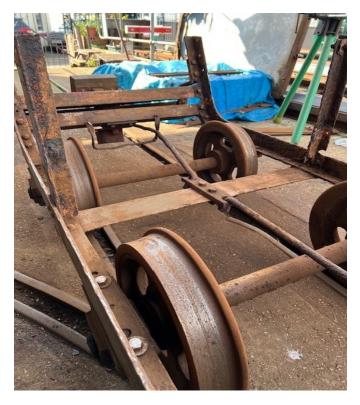
Photo J Drodge

Initial strip down complete, worst of the rust removed.

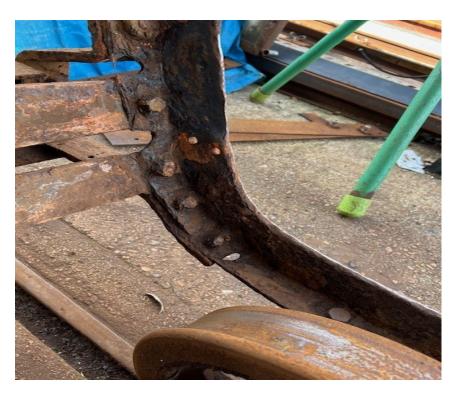
Photo J Drodge

This picture shows an area of the original frame where corrosion has eaten through the frame and will require replacement. This section will require to be cut out and a new fabricated part made. There appears to be sufficient steel off cuts in the workshop to fabricate the replacement part.
